**State of Louisiana
Department of Natural Resources
Coastal Engineering Division**

**2006/2007 Annual Inspection
Report**

**FOUR MILE CANAL TERRACING
AND SEDIMENT TRAPPING
PROJECT**

State Project Number TV-18
Priority Project List 9

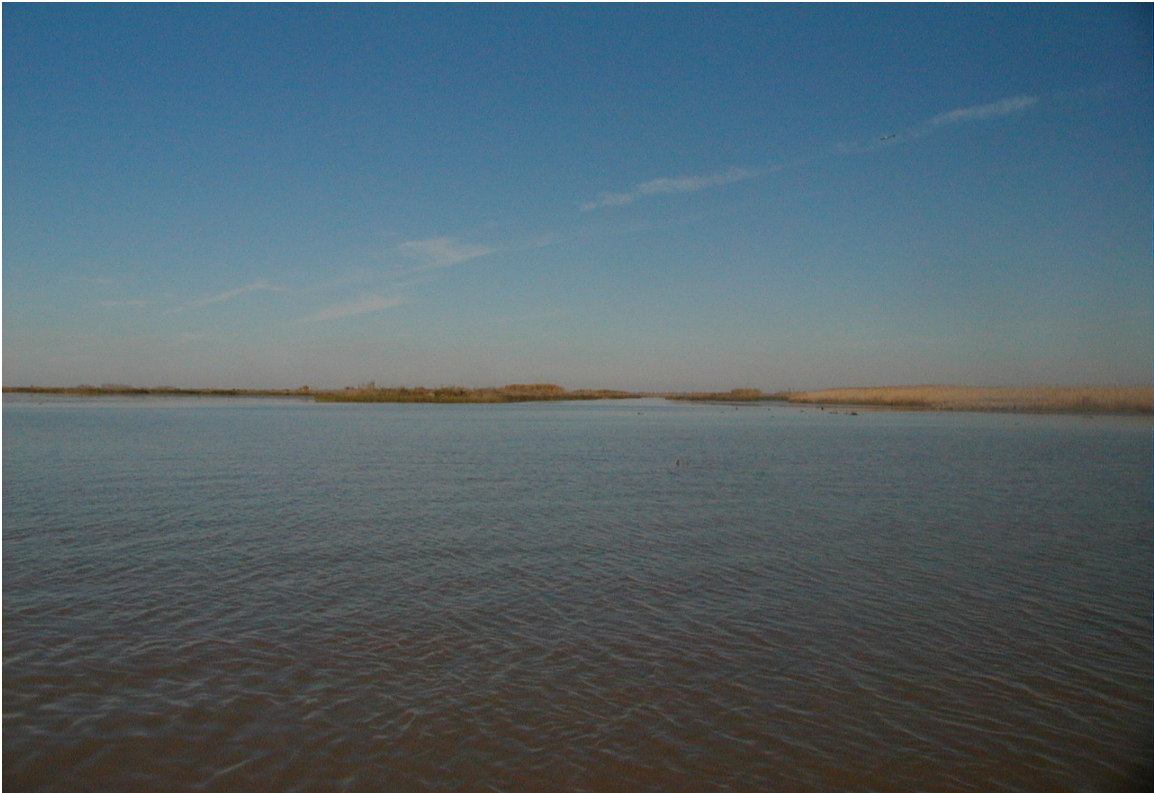
The terraces appear to be in fairly good condition. Terraces along the Vermilion River Cut-Off and on the southwestern rim of the project are eroding but are still functional. Submerged aquatic vegetation is becoming established between the terraces. No maintenance needed at this time. (Photos: Appendix B, Photo 1-4)

Photo 1—terraces along Vermilion River Cut-Off

Item	Condition	Physical Damage	Corrosion	Photo #	Observations and Remarks
Steel Bulkhead / Caps	N/A				
Steel Grating	N/A				
Stop Logs	N/A				
Hardware	N/A				
Timber Piles	N/A				
Timber Wales	N/A				
Galv. Pile Caps	N/A				
Vegetation	Good				
Signage / Supports	N/A				
Rip Rap (fill)	N/A				
Eathern Embankment Terraces	Good			1,2, 3 & 4	Expected erosion on sacrificial terraces. Significant erosion on terraces adjacent to Vermilion River Cut Off.

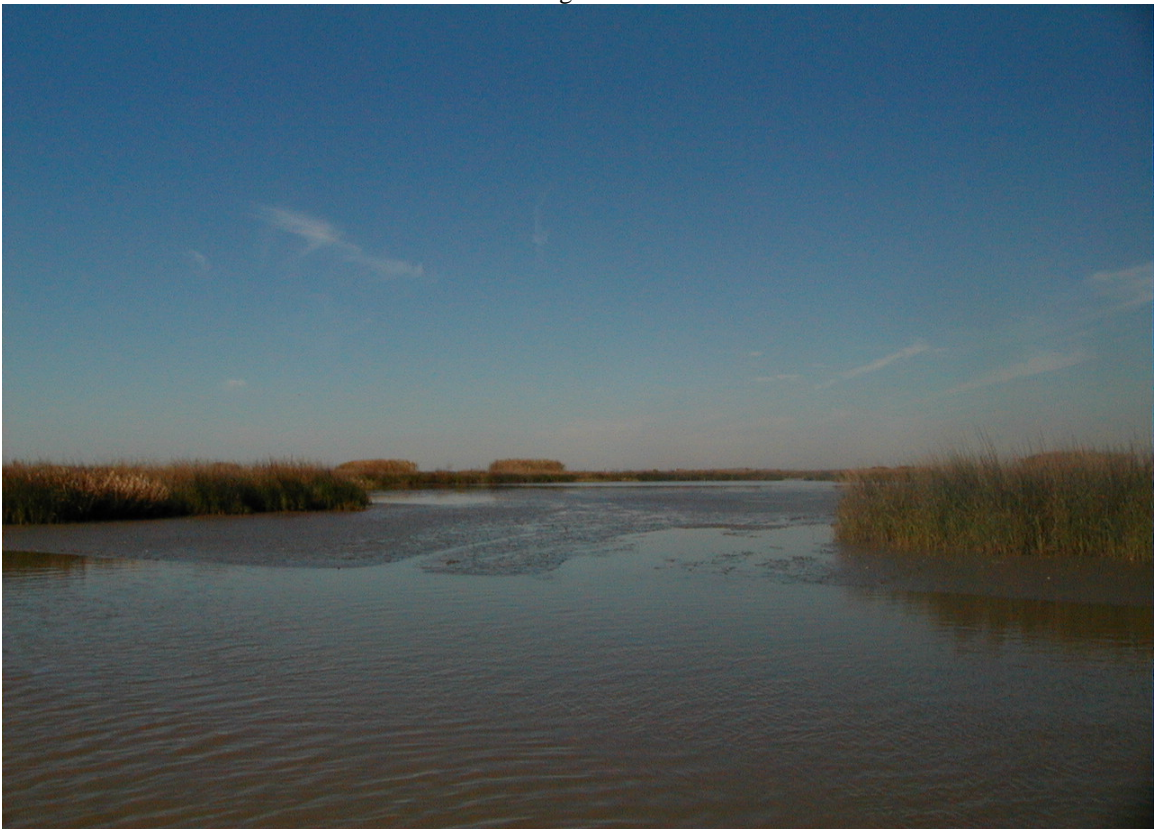
Photo 2—terraces in Little Vermilion Bay

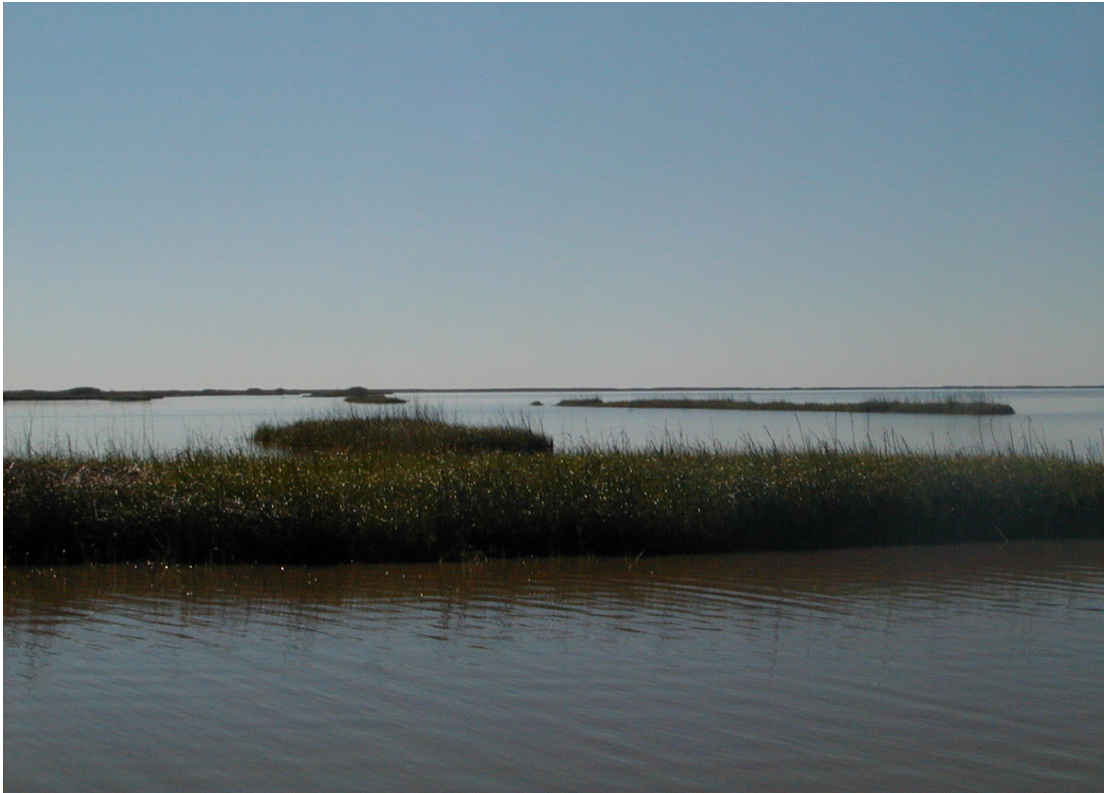
Photo 3—terraces in Little White Lake

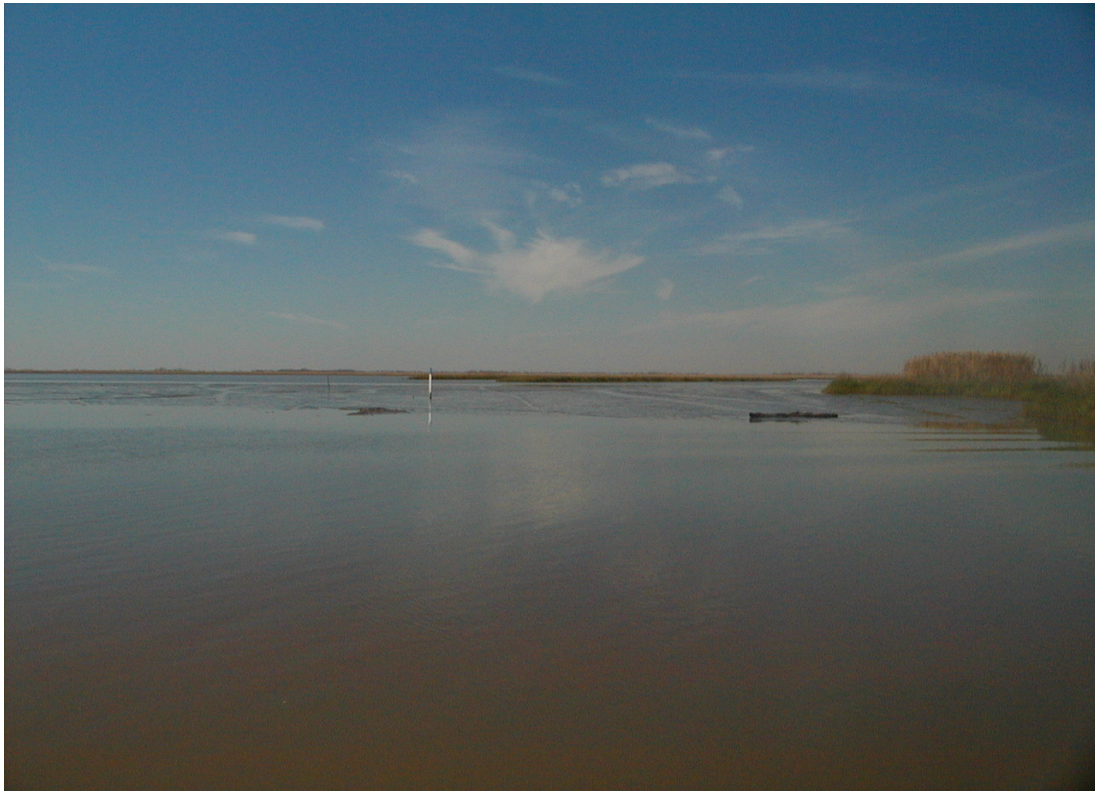
Photo 4—terraces in Little White Lake
